# FIRE EFFECTS ON HIGH EFFICIENCY COMPACT FLUORESCENT LIGHTING

Richard J. Meier, CFEI, CFII, CVFI  
October, 2012

**International Symposium on Fire Investigation  
Science and Technology**  
5<sup>th</sup> International Fire Investigation Conference  
University of Maryland,  
Hyattsville, Maryland USA

Richard J. Meier, CFEI, CFII, CVFI  
Staff Fire and Explosion Analyst  
John A. Kennedy and Associates  
Fire and Explosion Analysis Experts, USA

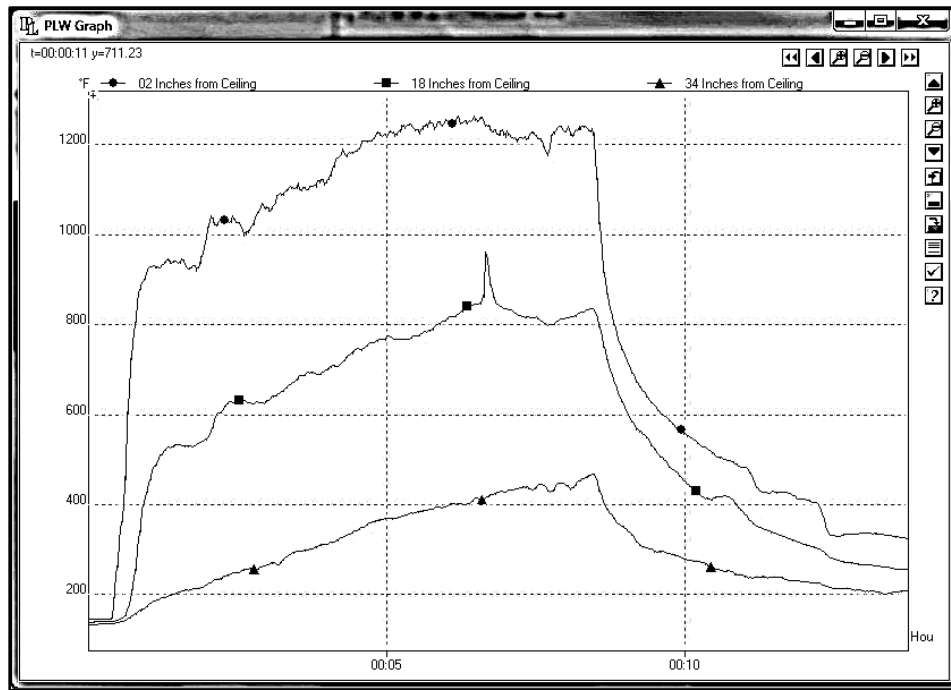
Figure 4.  
Typical Heat Profile of 1<sup>ST</sup> Round of Tests.

Experimentation showed that a minimum temperature of 650°C (1200°F) (measured at the uppermost thermocouple) for at least 5 minutes would distort some, though not all, of the glass light bulbs used as a control and baseline for the testing.

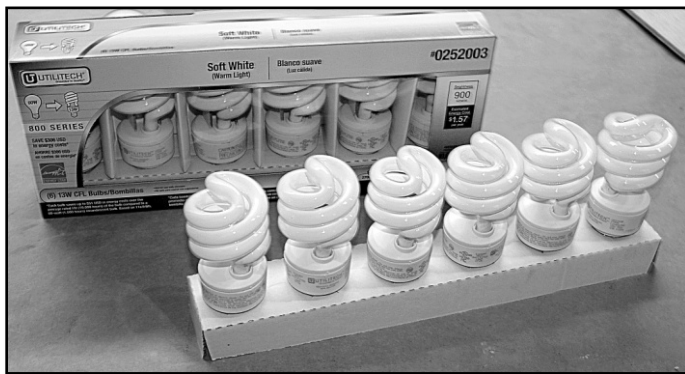
Figure 5.  
Helical Integrated CFL.

After test perimeters were established using tradition glass incandescent light bulbs, tests were conducted under similar conditions using compact fluorescent light bulbs. Two types of compact lights were used. The first was the helical integrated CFL (*Fig. 5*), currently the most popular design in North America.<sup>2</sup> The second type was a helical integrated CFL enclosed in a glass bulb—designed to mimic the size and shape of traditional incandescent bulb—known as an “A-Line” or “Type A” CFL<sup>5</sup> (*Fig. 6*). While other types of CFL’s exist in the market place, these are the most common drop-in replacements for incandescent lights.

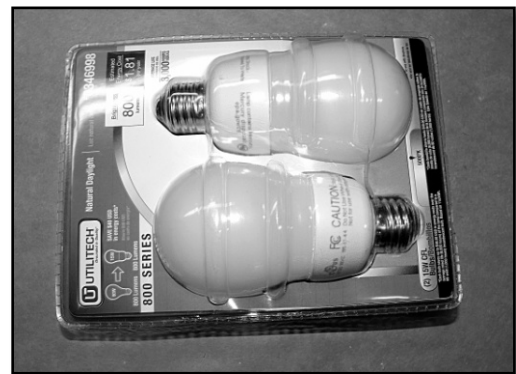
Figure 6.  
Type A CFL.

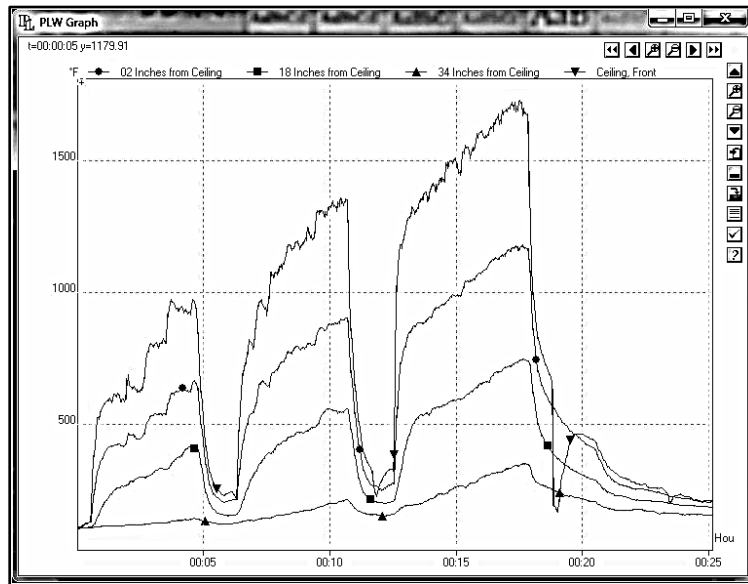
*Figure 7.  
Heat Profile from a Parallel Test.  
Note a 4<sup>th</sup> thermocouple was added in the ceiling jet.*

After the initial tests were completed, a second set of tests were conducted with the various types of lights “in parallel”, so results could be compared of all the lights exposed to exactly the same conditions. Five fixtures were placed on the ceiling 610 mm (24 in.) from front wall (except the center fixture which was slightly closer due to spacing issues). Two fixtures placed on opposite sides 760 mm (30 in.) from front wall and offset 102 mm (4 in.) from the ceiling.

During the parallel tests, three helical CFL’s, three Type A CFL’s and a single incandescent light (in the center fixture) were placed into the test chamber. The fire was lit and the chamber heated in stages so that the effects of the heat could be observed on each type of light at different points in temperature profile. After allowing the chamber to cool only long enough to be safely opened, photographs were taken and the chamber reheated to a higher temperature. The process was repeated until all of the CFL’s were destroyed.

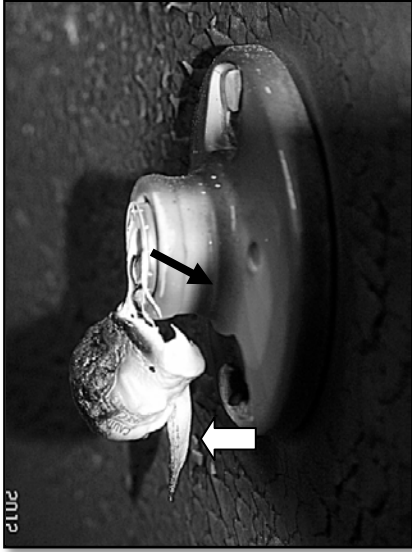
Figure 14b.

Same wall mounted helical CFL post fire.  
 Note un-charred side of housing away from ceiling jet.

Although little of the helical CFL's was left in the porcelain outlets used in the test, remnants remained in some of the fixtures which could aid in determining the direction of the ceiling jet. Due to uneven heating, the cooler side of the light would typically leave a "tail" hanging down indicating it took longer to soften and had the opportunity to stretch. Depending on the fixtures proximity to the fire plume the tail could burn away or remain intact after the fire.
